# ***Technical Data Sheet TDS-010***

## ***IntelliSense Error Messages***

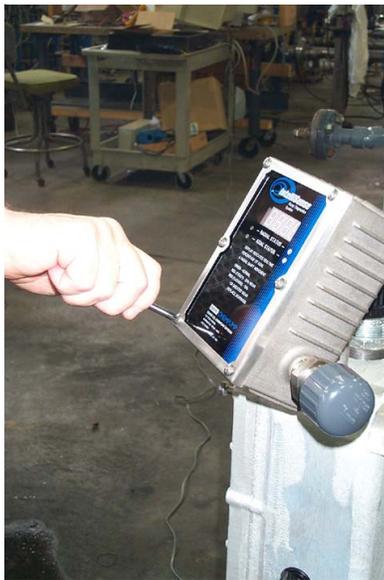
***Photo 1***

1. Remove the trim ring; cover plate and gasket from the DM connection box. See *Photo 1*. Be certain that all wires are inserted tightly into both the brown and white connectors. See *Photo 2*.

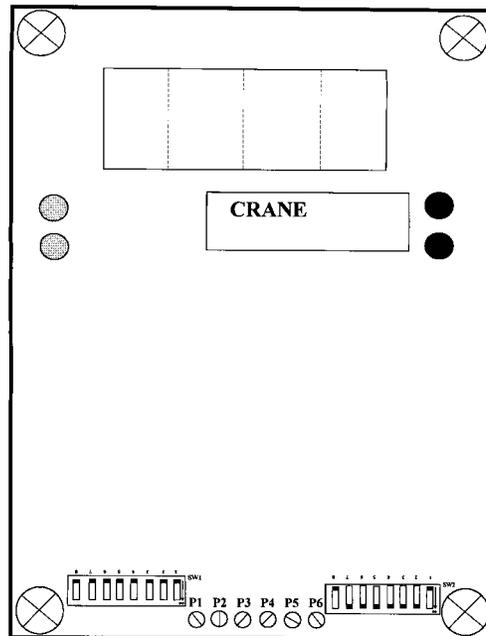
**Figure 1**

2. Move the left hand (SW1) Dipswitches #1, #2, and #3 to the “ON” (down) position. See *Figure 1*.

3. Move Dipswitches #1, #2, and #3 to the “OFF” (up) position. The IntelliSense diagnostic monitor should begin to operate properly.

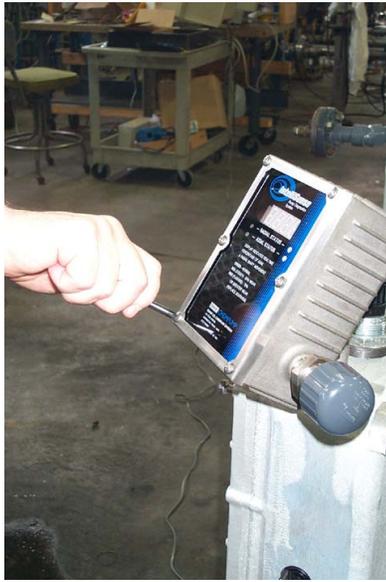
**Photo 3**

1. Remove the trim ring; cover plate and gasket from the DM connection box. See *Photo 3*. Be certain that all wires are inserted tightly into both the brown and white connectors. See *Photo 4*.

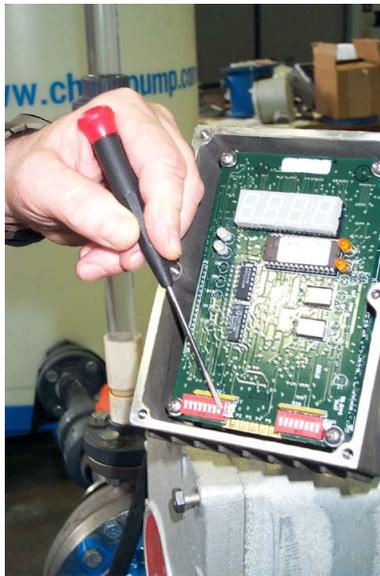
**Photo 5**

2. Move the left hand side (SW1) Dipswitch #5 to the "ON" (down) position. "CAL" appears momentarily in the display. When "CAL" disappears, return switch #5 to the "OFF" (up) position. See *Photo 5*. The IntelliSense display should return to the normal operating condition.

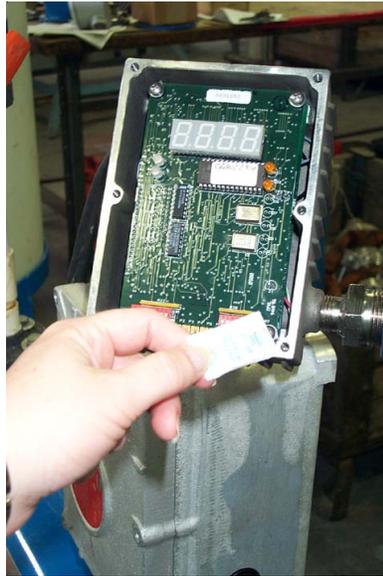
***Photo 6***

3. Place a new bag of desiccant into the IntelliSense housing. See *Photo 6*.

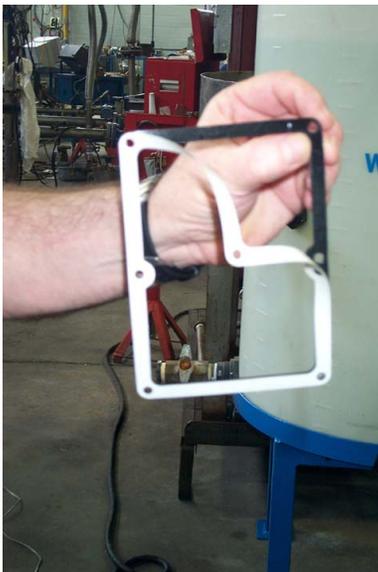
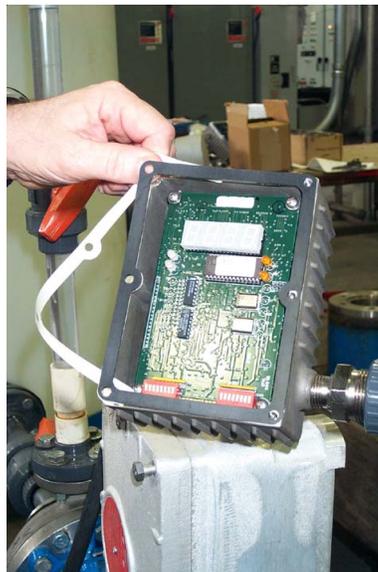
4. Install a new gasket. See *Photos 7 & 8*.

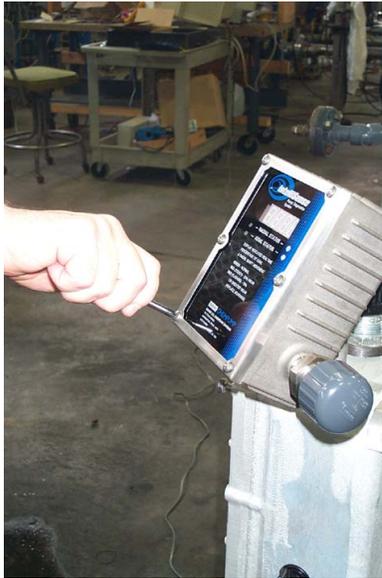
***Photo 9***

5. Replace the cover plate and trim ring. See *Photo 9*.
