# ***Technical Data Sheet TDS-005,006,007***

## ***IntelliSense Circuit Board Reinstallation & Calibration***

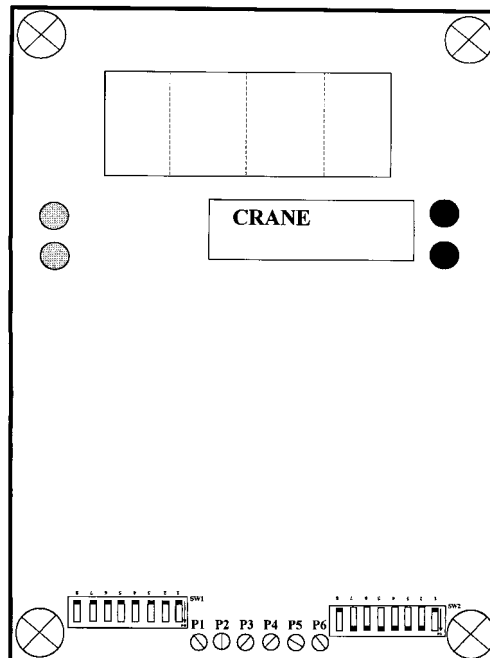
**Figure 1**

- A.) The DM boards should never be removed or installed while the pump is energized.
- B.) No more than one Dipswitch should be in the “ON” position at any time on the SW1 series of Dipswitches.
- C.) See *Figure 1* for location of all Dipswitches and potentiometers.

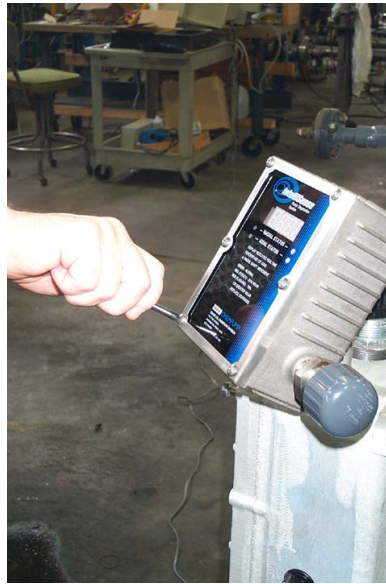
**Photo 1**

1. Remove the trim ring; cover plate and gasket from the DM connection box. See *Photo 1*.

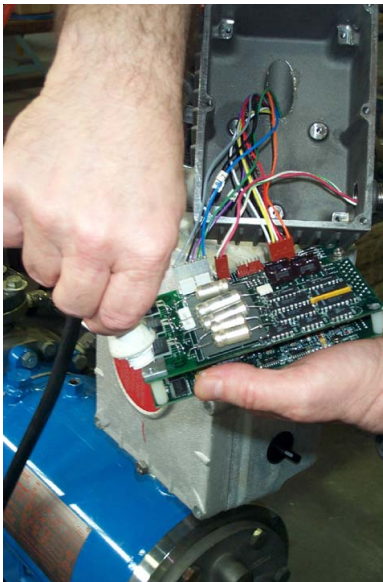
**Photo 2**

2. Apply thermally conductive paste (Radio Shack Part Number 276-1372, or equivalent) to points of contact between the DM connection box (top screw holes) and the heat sink on the circuit boards. See *Photo 2*.
3. Install the connectors to the appropriate DM circuit board pins making certain that the wiring harnesses are tight and locked into place. See *Photo 3*.

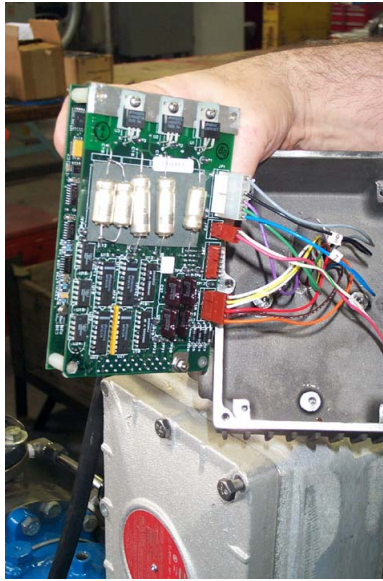
**Photo 5**

4. If any remote outputs have been provided these connections should also be made at this time. See *Photo 5*.

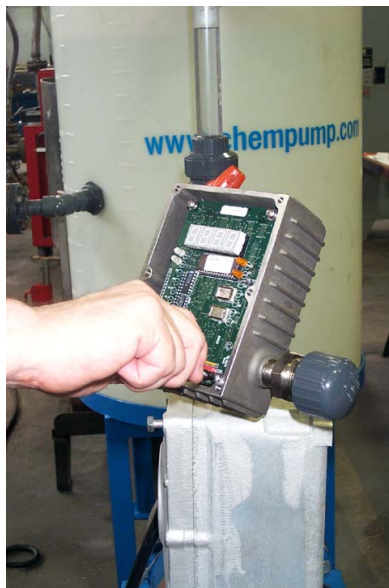
**Photo 6**

5. Mount the circuit boards to the connection box with the four (4) mounting screws making sure that the screws are tight. See *Photo 6*. Note that the mounting screws come in two lengths. See *Photo 7*. The longer screws go into the top two mounting holes and the shorter ones go into the bottom two mounting holes.

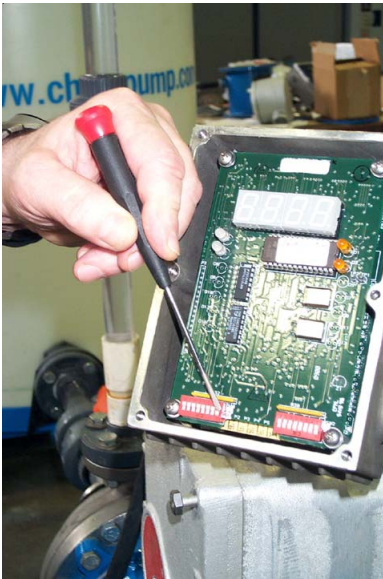
**Photo 8**

6. Start pump and allow the IntelliSense system to stabilize temperature for 10 to 15 minutes. Move the left hand side (SW1) Dipswitch #5 to the “ON” (down) position. “CAL” appears momentarily in the display. When “CAL” disappears, return switch#5 to the “OFF” (up) position. See *Photo 8*.
7. For complete recalibration, move the left hand side (SW1) Dipswitch #1 to the “ON” (down) position. Adjust pot #6 to obtain the number closest to zero (0). The sign of the number should change between + and – on the display. Return switch #1 to the “OFF” (up) position. See *Photo 9*.
8. For complete recalibration, move the left hand side (SW1) Dipswitch #2 to the “ON” (down) position. Adjust pot #4 to obtain the number closest to zero (0). The sign of the number should change between + and – on the display. Return switch #2 to the “OFF” (up) position. See *Photo 9*.

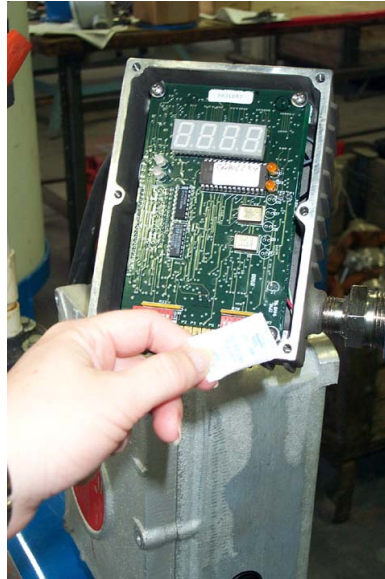
**Photo 10**

13. Place a new bag of desiccant into the IntelliSense housing. See *Photo 10*.

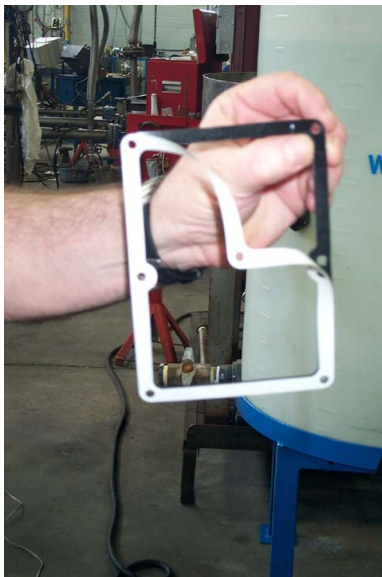
**Photo 11**

14. Install new gasket. See *Photos 11 & 12*.

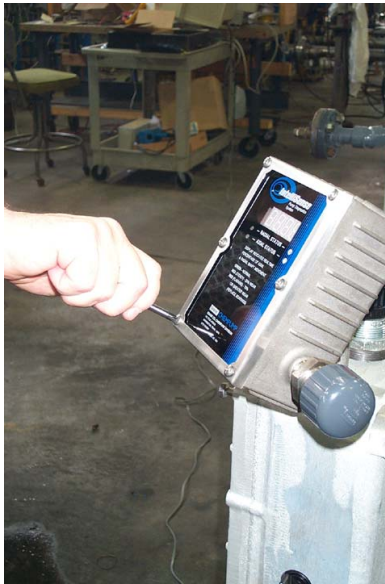
***Photo 13***

15. Replace the cover plate and trim ring. See *Photo 13*.
